Water Purification

MetaLine Repair and Coating Systems

Filters / Water-Management

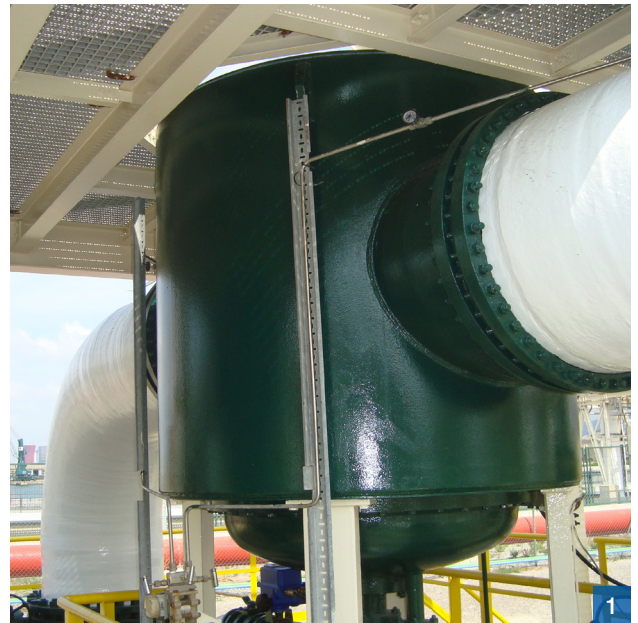
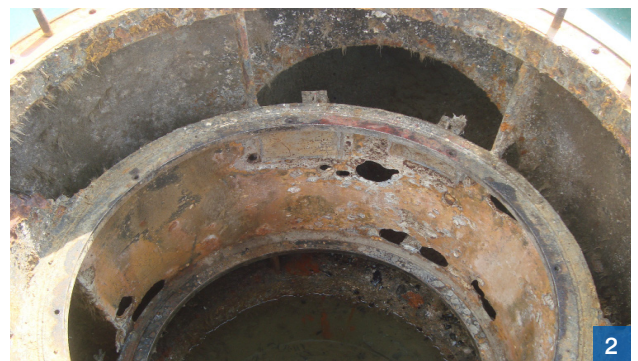
- 1 Massive filter cartridge located in the port of Barcelona/Spain
- 2 Severe corrosion and complete destruction of the filtering area
- 3 Mechanically repaired and treated with 1 coat of MetaLine 924
- 4 During the spray application of 2,5 mm MetaLine 785 in red
- 5 What a complex shape! Nevertheless successfully coated . . .
- 6 A tough job, finished in time by a spanish MetaLine partner

MetaLine 785 - Elastomeric rubberlike protective coating answers today's need for highly abused, corrosion impacted steel surfaces. Resists mechanical shocks & pressurized working conditions. A tough, seamless & durable skin to armour stressed filter equipment
