Kort Nozzles / Thrusters

Jet Drives

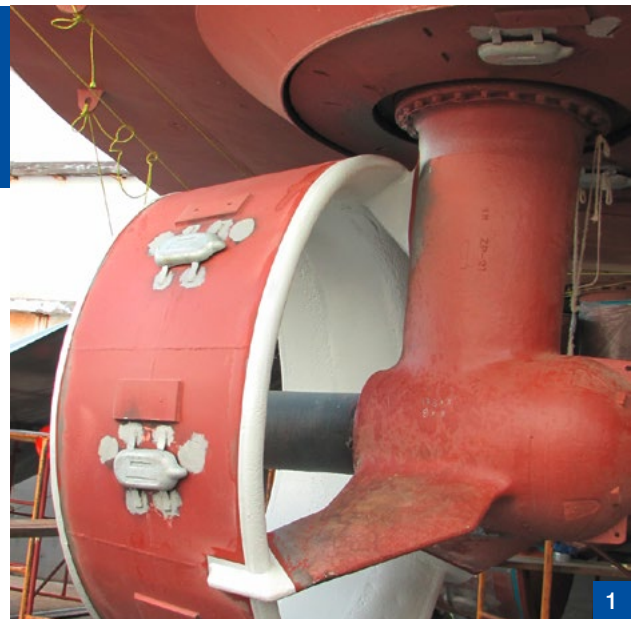
- 1 Elastomeric MetaLine 785 has given new life to the nozzle ring
- 2 Both thrusters showed massive cavitation & erosion damages
- 3 After the reconstruction (welding) with new 13 mm steel plates
- 4 Gritblasting in tropical conditions like the Gulf of Mexico is a challenge. Air-dryers are a must to keep the surface moisture low
- 5 MetaLine 924 as a first borderline corrosion protection treatment
- 6 Ready to leave drydock after 2 days of professional coating work

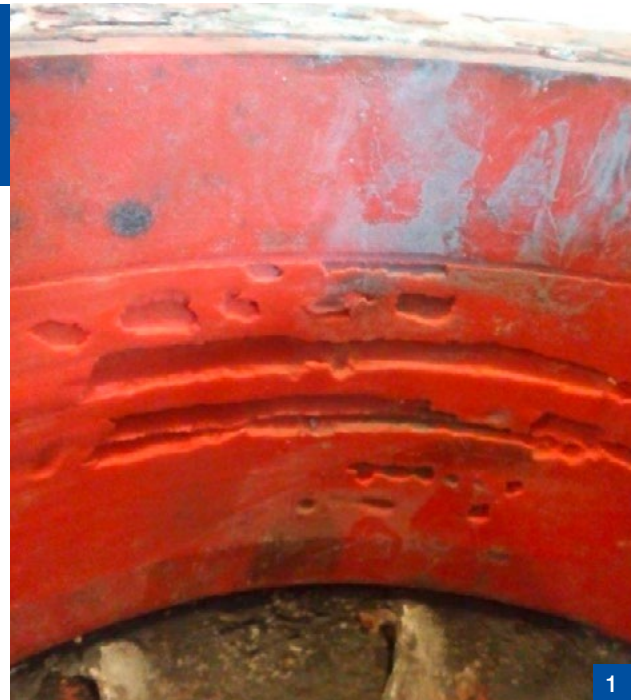
- 1 Wear (i.e. corrosion and cavitation) on the original lining of the housing
- 2 Pitting corrosion in its most severe form on the stator of a coast patrol vessel
- 3 The viscous film seamlessly covers all metallic areas
- 4 Fits just like a custom-made shoe – no abrasion damage after 3 months of operation
- 5 Anti-fouling properties protect against growth in case of extended non-use
- 6 After inspection – can be reused again without any further repairs necessary
