Pump volute refurbishment

MetaLine - a unique technology to repair

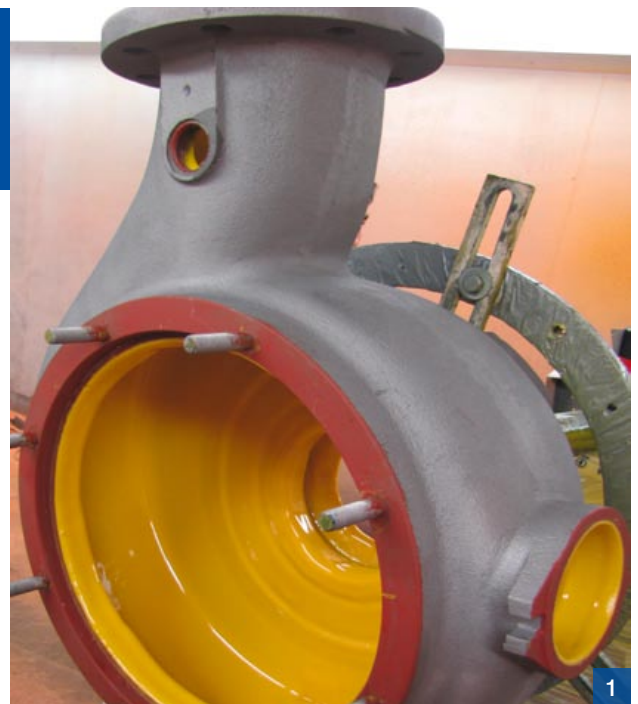
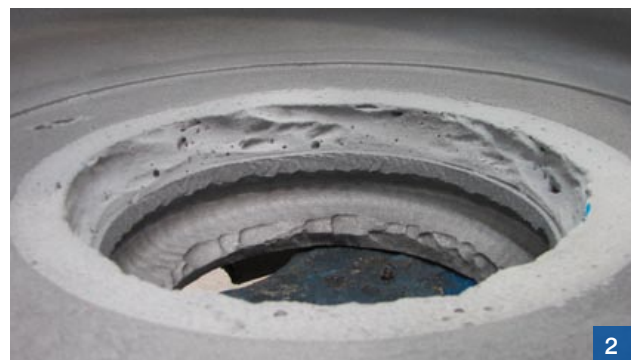
- 1 Nothing unusual on the first view - if you have not seen the massive damages before
- 2 Severe erosion and locally pitting corrosion with up to 15 mm loss of substrate
- 3 A must for the long-term protection process - MetaLine 924 borderline corrosion protection
- 4 A simple plastic shape to mold could save the complete mechanical tooling work
- 5 In a single step everything was restrucured - immediately followed by the spray-coating
- 6 Instead of plastic molds, thin sheet metal rings could be used as well

Reconstruction & coating in a single workstep (!) by use of the moldable and sprayable MetaLine Series 700 Elastomeric coatings. Time and cost intensive mechanical treatments like lathe operation or milling can be often avoided.
